Road Conditions for Antenna Transportation from San Pedro de Atacama to Pampa la Bola

Information of the road from San Pedro de Atacama to the Pampa la Bola site was collected for transportation operation of a 10-m antenna. Inclinations and widths of the road were measured. Turnouts, opencuts, and obstacles were located. It appears to be possible to transport a 10-m dish with a double tractor and trailer from San Pedro de Atacama to the Pampa la Bola site.

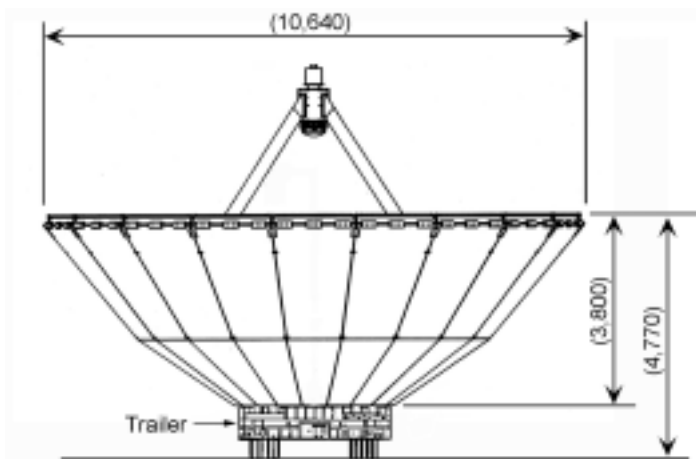
Figure 2. A 10-m main dish on a trailer

a unit of the 10-m main dish (13 ton) and three units of the telescope mount (30, 11, and 11 ton). In the latter case, we transport the main-dish unit with a trailer (see Figure 2), which needs to examine the road over 62 km from San Pedro de Atacama to Pampa la Bola. As the first step, we have collected information relevant to transportation of a 65-ton, 10-m antenna, such as widths and inclinations of the road, locations and sizes of turnouts, locations of obstacles for a large-size vehicle, etc.

Opencuts are danger zones in the route. The 10-m main dish on a trailer may hit a sidewall of the opencuts. In particular, the second and third opencuts in the list have steep walls (see Photographs B-12, 13, 14, and 20). It would be better to have a pedestal between the carrier bed and the base of the main dish to have more clearance (Figure 2).

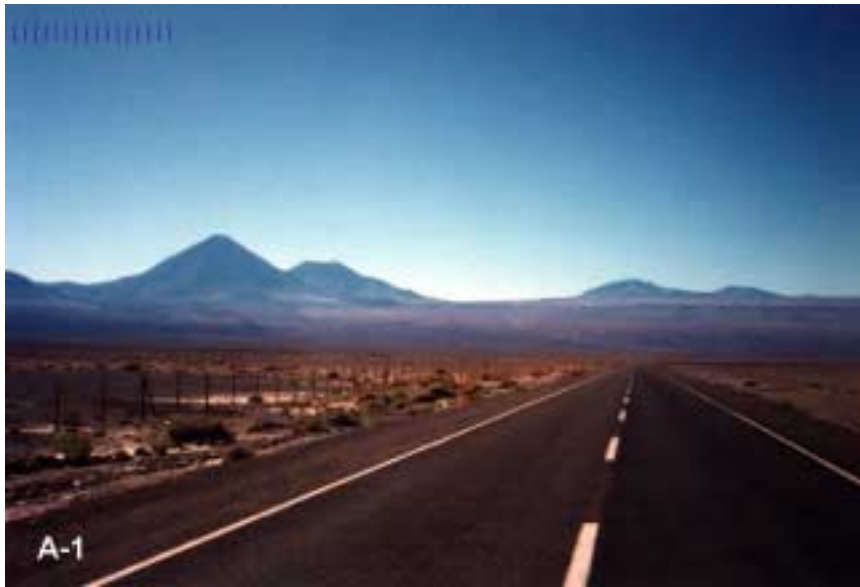
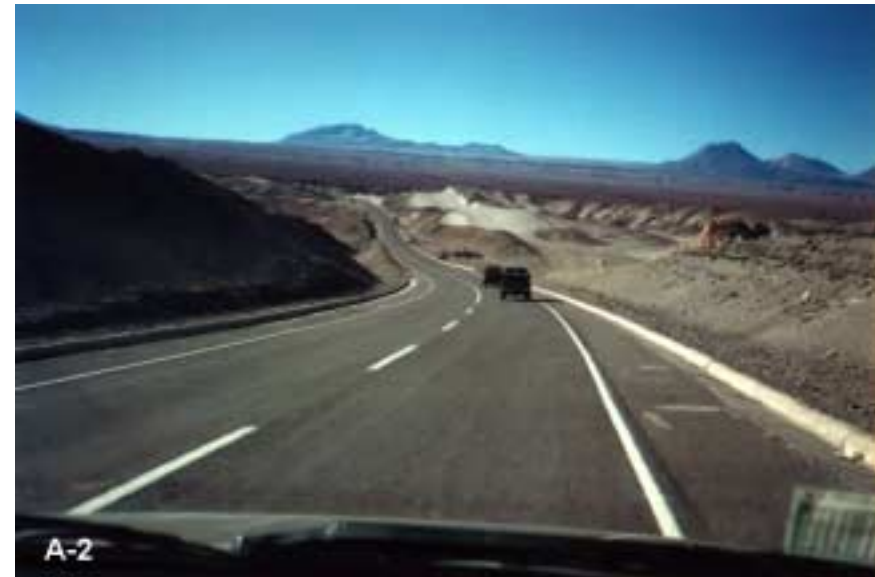
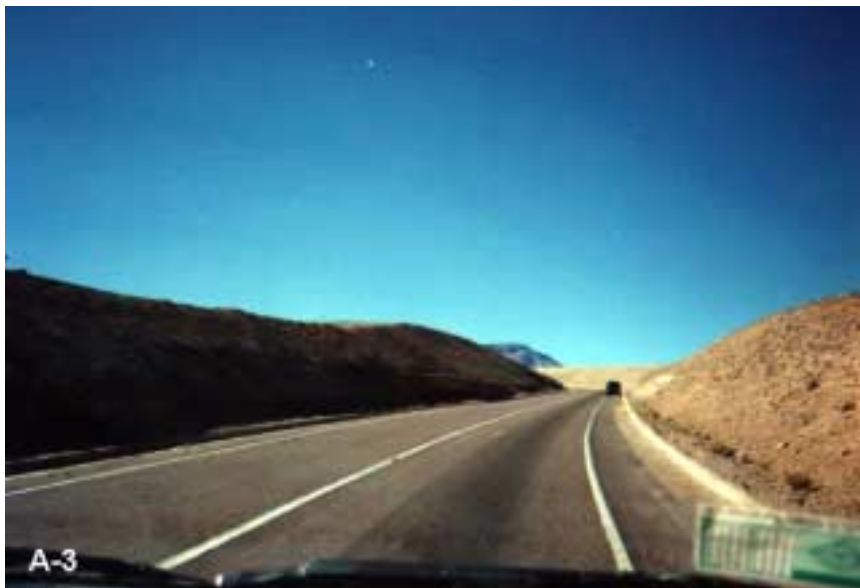
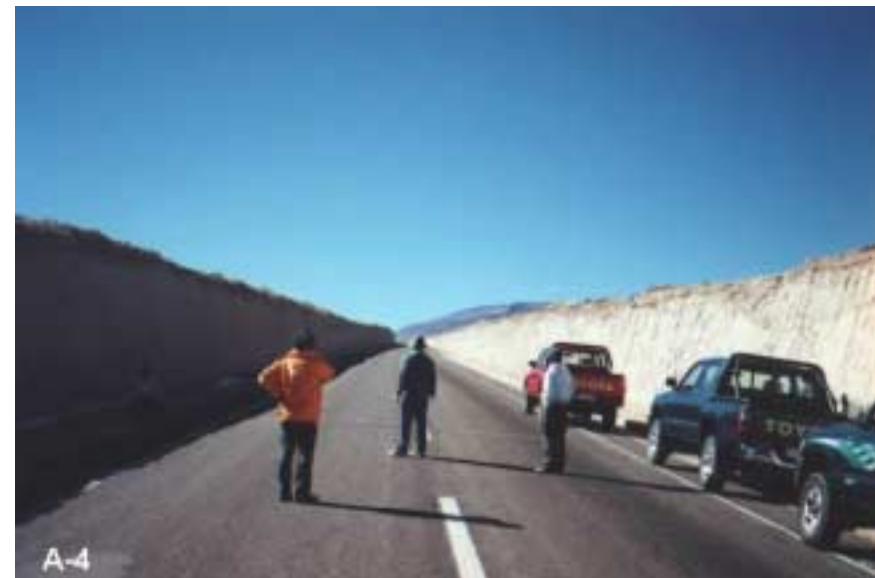
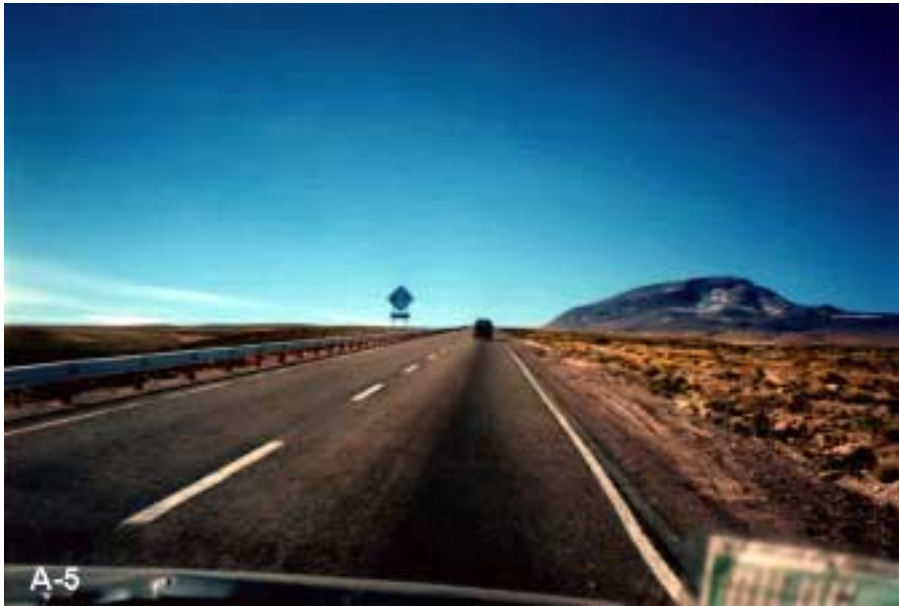
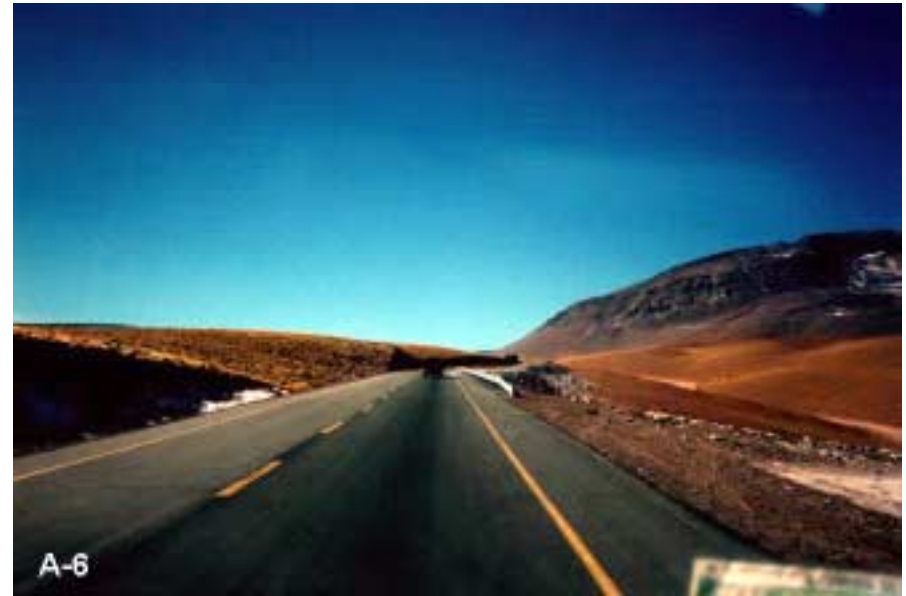
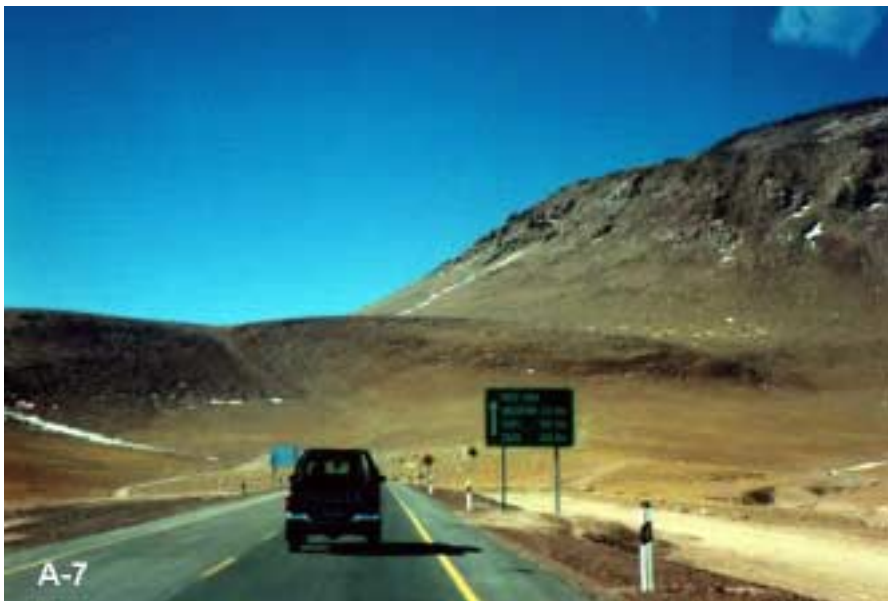
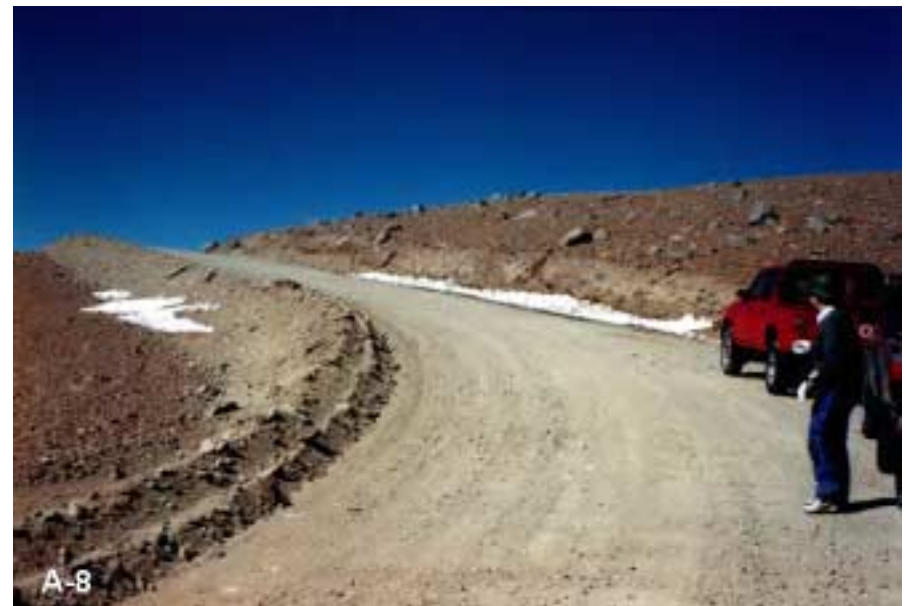
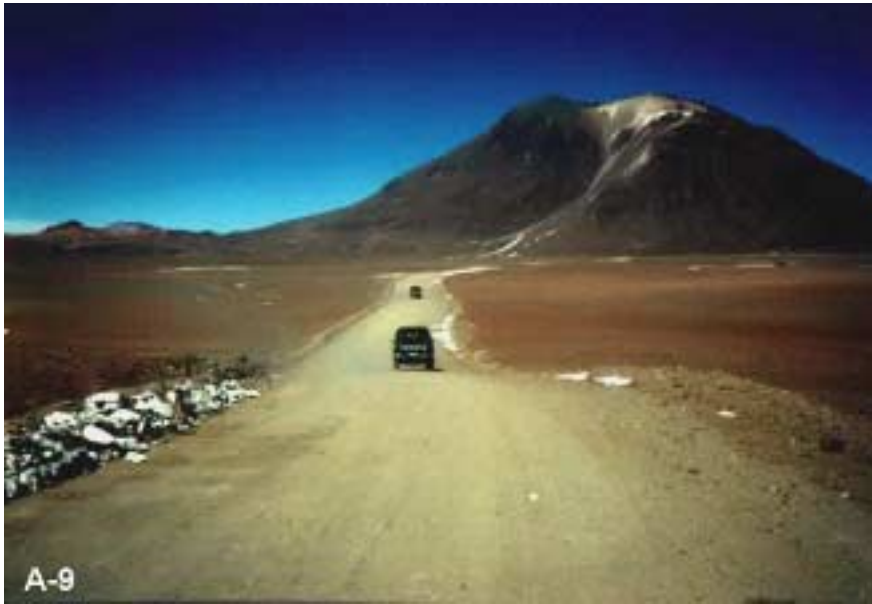
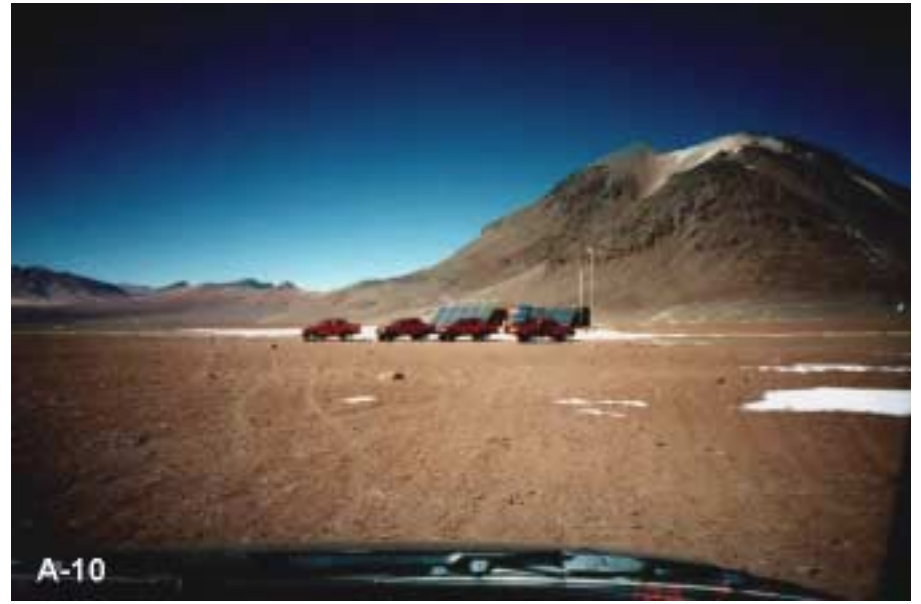
Appendix A

No	Distance [km]	Road Condition	Inclination [deg]	Comments	Photo No.
1	0.0 ~ 9.4	flat	< 1		A-1
2	9.4 ~ 11.2	gentle slope	about 2		
3	11.2 ~ 11.8	gentle down slope	about -2		A-2
4	11.8 ~ 28.5	gentle slope	3 ~ 5		
5	28.5 ~ 29.5	steep slope	6 ~ 7	opencut #1	A-3
6	29.5 ~ 30.1	steep slope	about 5		
7	30.1 ~ 30.8	steep slope	about 6	opencut #2	A-4
8	30.8 ~ 35.8	gentle slope	3 ~ 5		A-5
9	35.8 ~ 40.9	S-curved gentle slope	3 ~ 5		A-6
10	40.9 ~ 41.3	S-curved gentle down slope	2 ~ 3		
11	41.3 ~ 57.6	gentle up/down slope	< 2 ~ 3		A-7
12	57.6 ~ 61.2	unpaved	< 5	The moraine section has an inclination of 8 degree.	A-8,9
13	61.2 ~ 61.6	gentle down off-road slope			A-10

from pyroclastic flow; a stream of heated rocks and volcanic ash produced by large-scale volcanic eruptions. The highway, which goes from San Pedro de Atacama to Argentina, was recently paved, and was in good conditions over the entire course except for one location (Location #21 in Table 2, Photograph B-16). There are neither rapid curves nor steep up-and-down slopes. There are five opencuts in the highway. No houses are built along the highway. At 58 km, the route branches off the highway, and leads to the LMSA/ALMA site. It is an unpaved road. The final access pass to the telescope site was in an off-road condition (Photograph A-10).

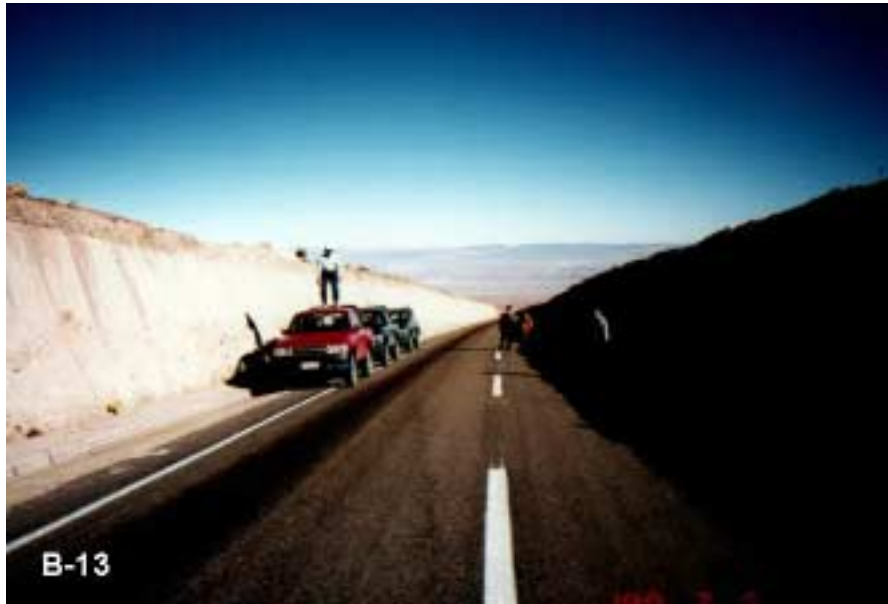
B-12
17	Opencut #2	30.6	Span of 12.1m; road inclination of 6°	27	-67.903125	-22.916641		B-13
18	Opencut #2, end	30.8		28	-67.900609	-22.916952		B-14
19	Turnout #11	31.7	On the left side	29	-67.893094	-22.917778		
20	Turnout #12	32.4	On the right side	30	-67.887182	-22.920128		B-15
21	Caution: Soft-shoulder	35.0	The right shoulder outside a guardrail was collapsed.	31	-67.863332	-22.929097		B-16

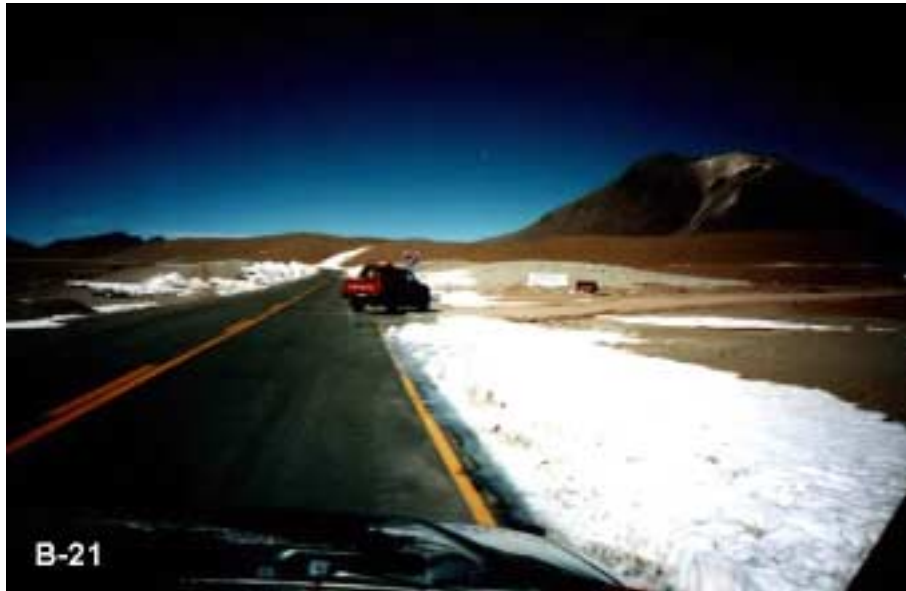
32	Turning point to Pampa la Bola	57.6	Turn right to the ALMA/LMSA site. (Notice board of Osengtel)	39	-67.687116	-22.945689		B-21
33	Moraine	58.2	The maximum inclination pitch of 8°; a roll angle of 2~3°; unpaved road	40	-67.688903	-22.948704

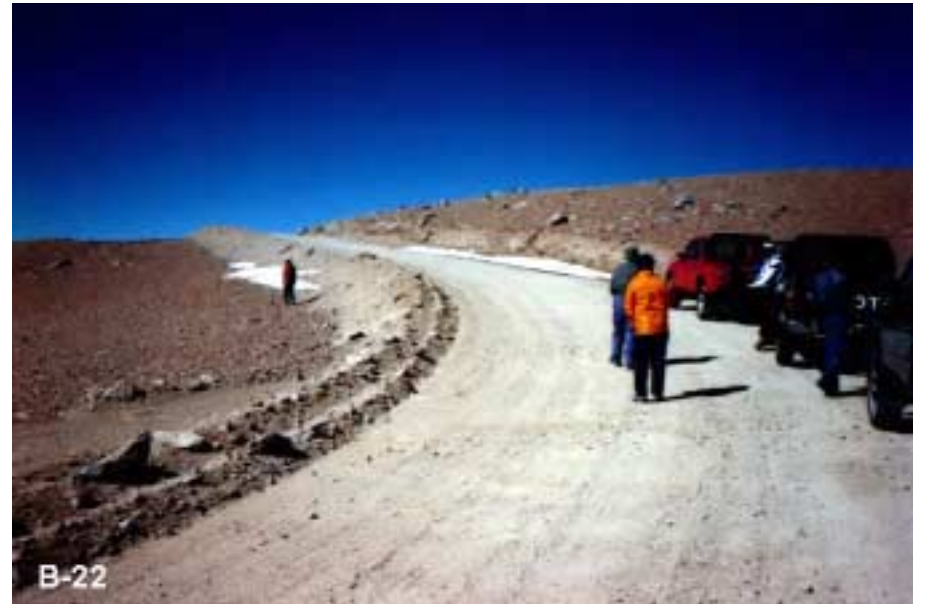
B-22

One of the most difficult spots in the route seems to be the location #33 in Table 2 at which a transporter rides over a moraine. The road is a S-shape curve, and is currently unpaved (Photographs B-22). The maximum inclination was 8 degree, and the maximum roll angle was about 3 degree. It seems to be impossible for a standard 4 drive-wheel tractor to restart climbing with a 30-ton load trailer on such a steep unpaved slope ($\mu=0.4$). Possible measures would be (1) to pull the trailer with a twin tractor, (2) to pave the slope ($\mu=0.7$), (3) to reduce the slope to an inclination of about 5 degree.

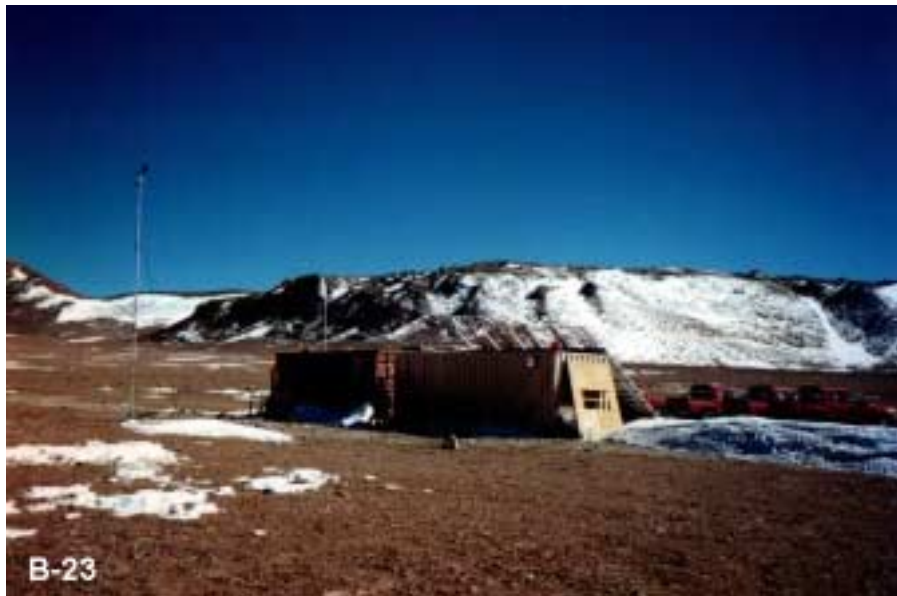
B-22
34	To the site	61.4	From unpaved road to off-road	41	-67.704637	-22.969271		
35	LMSA containers	61.8		42	-67.702662	-22.969008		B-23
36	ASTE telescope		300 m SSE of the LMSA container houses	46	-67.703242	-22.971728		B-24
